## CS 3500 Intraoral Scanner

# Crown preparation and placement with the CS 3500 intraoral scanner and CS 3000 milling system

Daniel C. Delrose, DDS

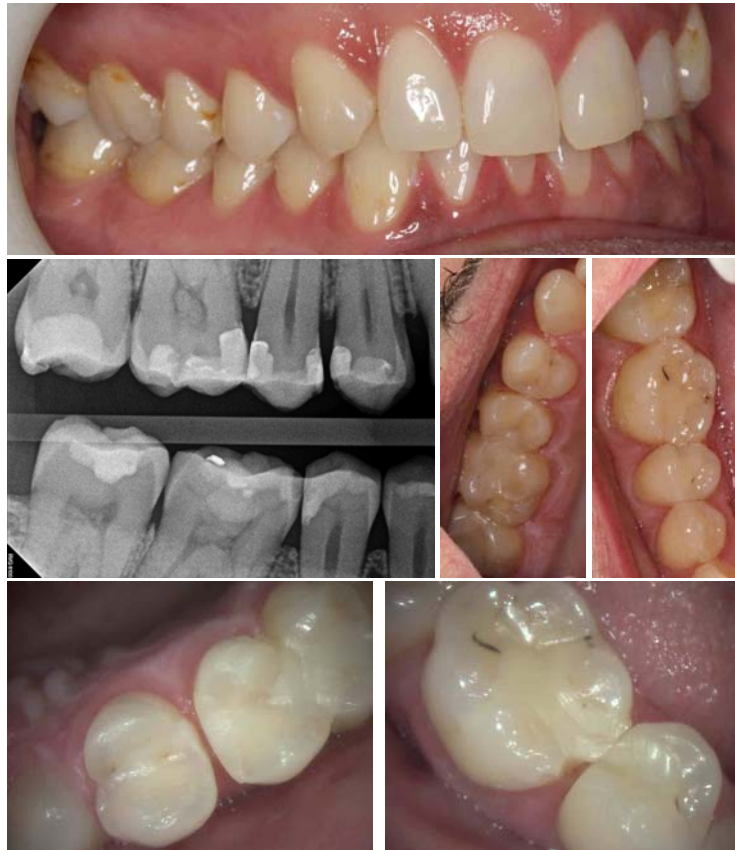
Top: Pre-treatment, patient's right side. Middle left: Pre-treatment bitewing radiograph. Middle center: Pre-treatment intraoral photograph Tooth #4. Middle right: Pre-treatment intraoral photograph, Tooth #30. Bottom left Pre-treatment intraoral photograph Tooth #4. Bottom right: Pre-treatment intraoral photograph Tooth #30.

Thirty-six year old male presents with some dental issues on his right side. A full review of his medical history reveals no medical issues and no known drug allergies. His dental history involved multiple direct restorations with a history of failure over time. Patient's chief dental complaint is to have a restoration that will endure longer than a few years.

A full dental examination was completed, including a CBCT scan with the CS 9300, a full series of intraoral radiographs with the RVG 6100; intra and extra oral photographs, hard tissue examination, and a soft tissue examination.

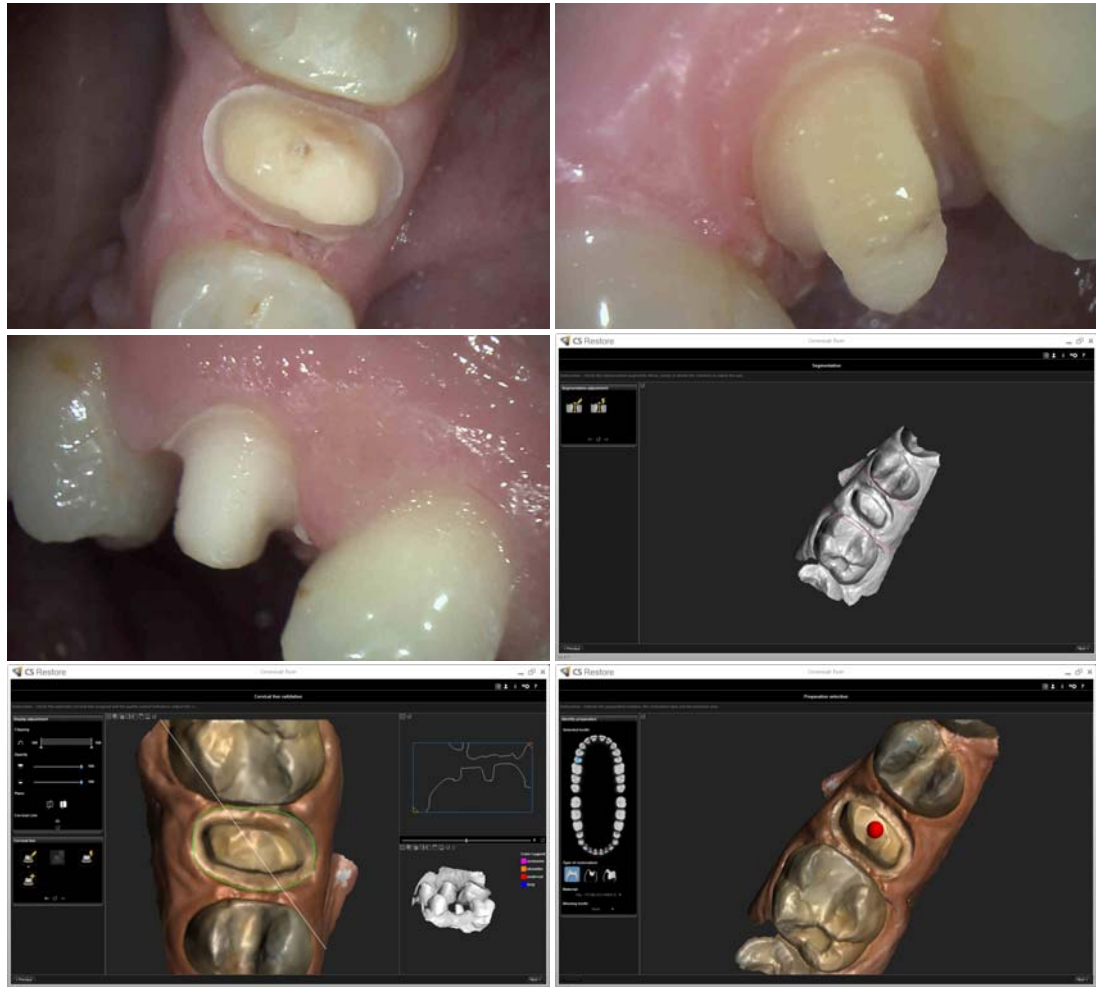
Top left, top right, and middle left: Prep of Tooth #4 Middle right: Segmentation of Tooth #4 in CS Restore software. Bottom left: Margin of Tooth #4 in CS Restore software. Bottom right: Preparation selection of Tooth #4 in CS Restore software.

Tooth #4 had an existing MOD composite with recurrent decay at the margins. The tooth was “over filled” and lacked integrity. To provide strength and function to the tooth, a full ceramic crown treatment was planned.

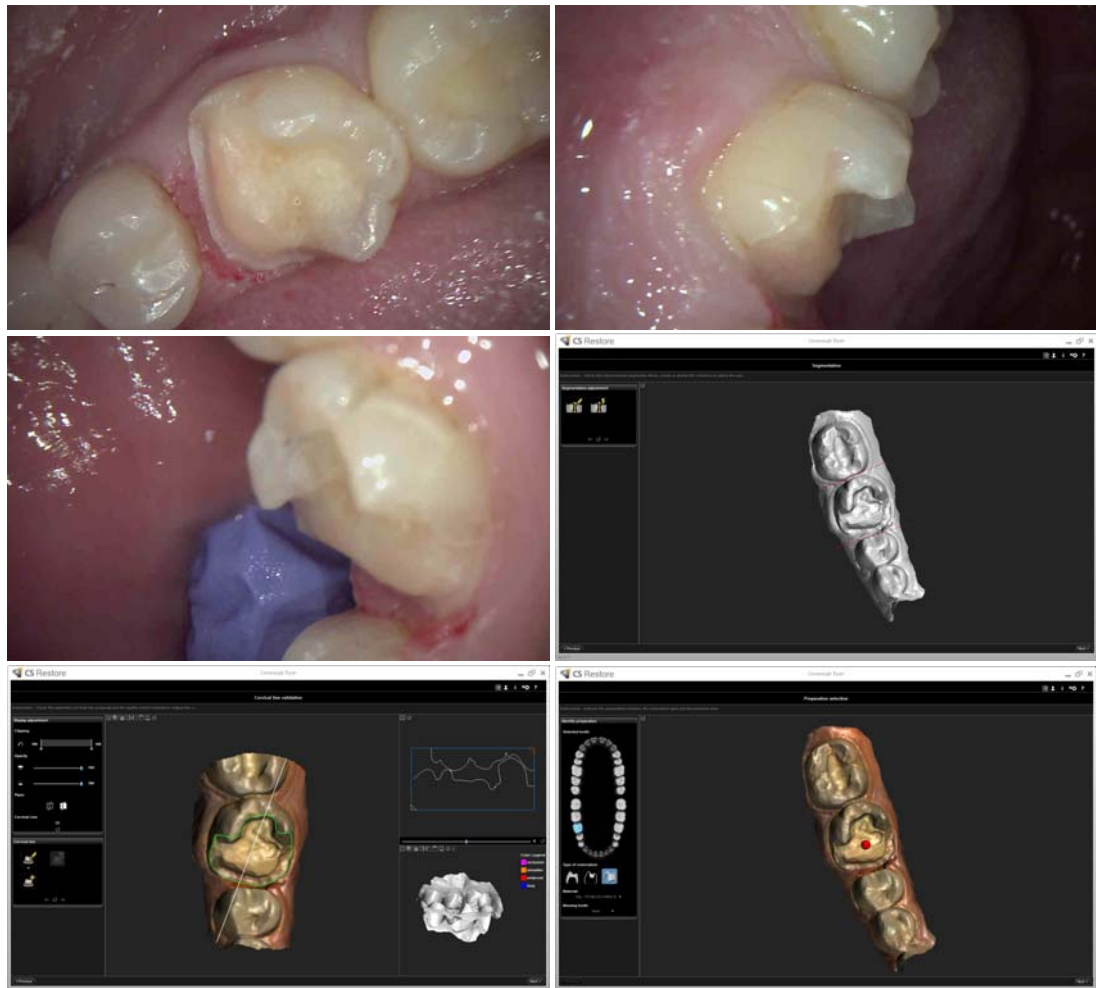
Top left, top right, and middle left: Prep of Tooth #30 Middle right: Segmentation of Tooth #30 in CS Restore software. Bottom left: Margin of Tooth #30 in CS Restore software. Bottom right: Preparation selection of Tooth #30 in CS Restore software.

Tooth # 30 had recurrent decay on the lingual and a fractured MO composite. Since healthy tooth structure existed and the tooth was not a point for full coverage, an onlay treatment was planned. Porcelain onlays bond to the existing enamel which restores a tooth to contour and function without dramatically removing healthy enamel. The preparations were completed using SOLO diamonds from Premier. The burs included the 368023C; 856L108C; 801023C; 862012C; 837012C; 368023F. Traxodent from Premier Dental was placed at the margins, rinsed and then imaged with the CS 3500.

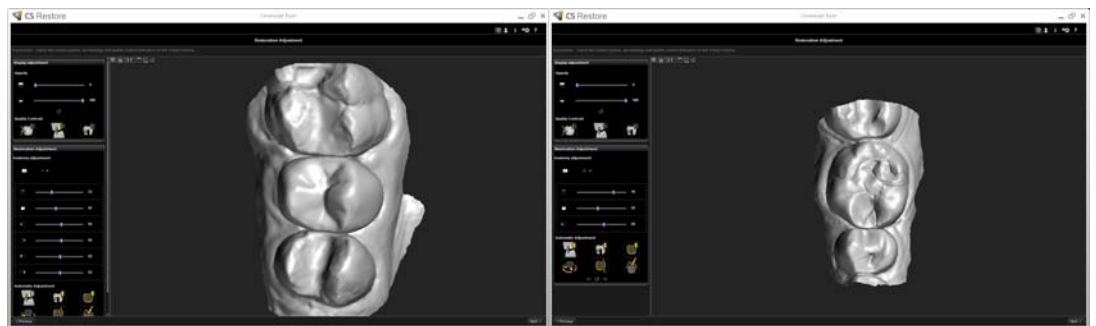
Left: Design of crown for Tooth #4 in CS Restore software. Right: Design of crown for Tooth #30 in CS Restore software.

The restorations were designed on CS Restore and then milled using the CS 3000 and Vita Mark II feldspathic porcelain.

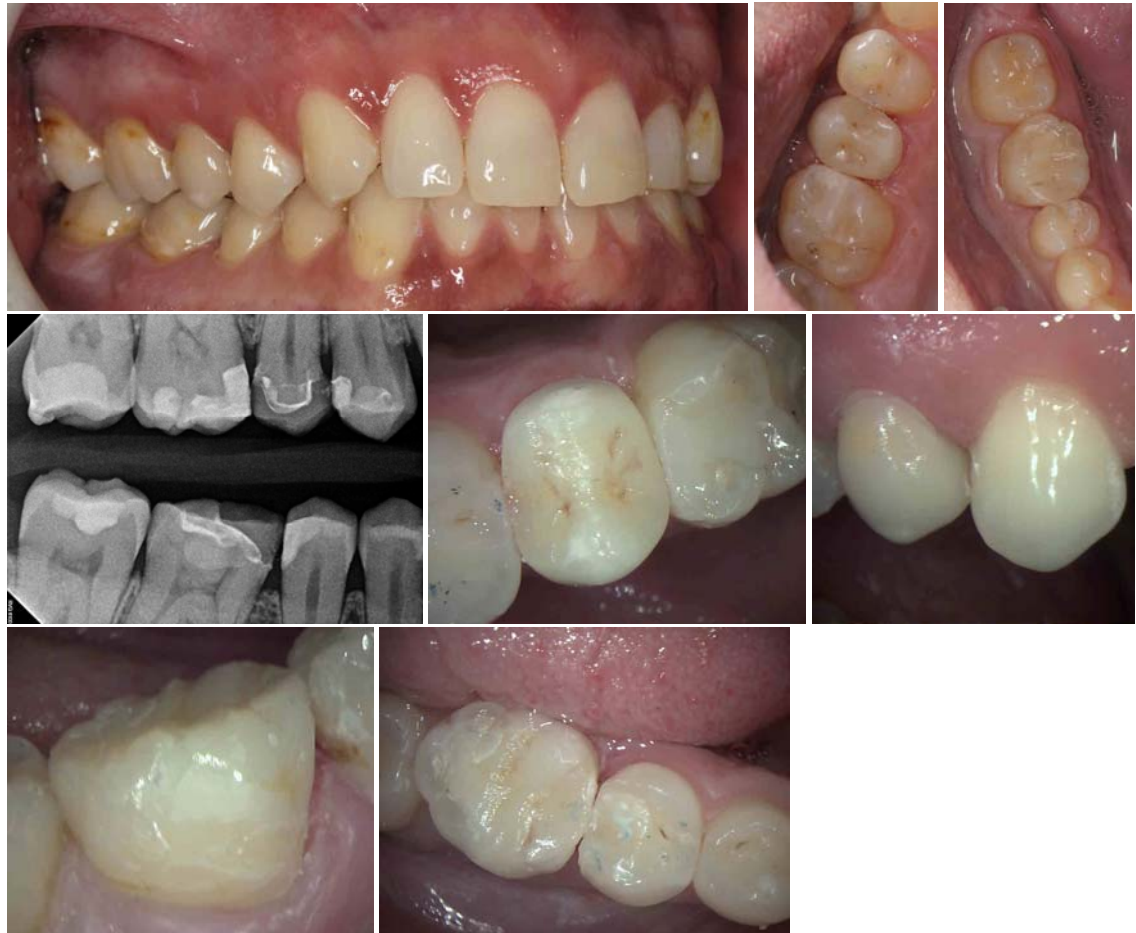
Top: Post-treatment, patient's right side. Top center: Post-treatment, Tooth #4 Top right: Post-treatment, Tooth #30. Middle left: Post-treatment bitewing radiograph. Middle center: Post-treatment intraoral photograph Tooth #4. Middle right: Post-treatment intraoral photograph Tooth #4. Bottom left and right: Post-treatment intraoral photographs, Tooth #30

The restorations were adjusted in the mouth and then stained and glazed using the Vita Akzent Plus kit. The preparations were then cleaned with 37% phosphoric acid, and Microprime from Danville Materials was used as a primer. Clear MaxCem Elite dental resin cement was used to lute the restorations. The SOLO fine flame bur was used again to polish the margins, and then Diamond Twist SCO from premier was used intraorally for the final polish. Radiographs are always taken to verify marginal integrity.
