## CS 9300 System

# CBCT Verifies Palatal Root Fracture Prior to Proposed Sinus Lift

Bradley McAllister, DDS, PhD

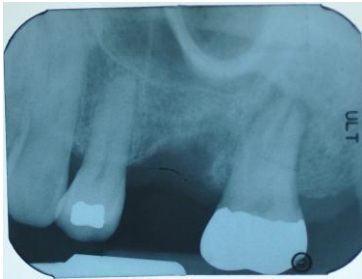
Figure 1: Post-extraction periapical taken at two month follow-up. A sinus lift was recommended prior to implant

A female, aged 55 years, was referred for implant replacement of a maxillary first molar. The referring dentist recommended evaluation for a possible sinus lift prior to implant placement due to inadequate bone and evaluation of tooth #15. A periapical radiograph taken at a two month follow-up was included (see Figure 1).

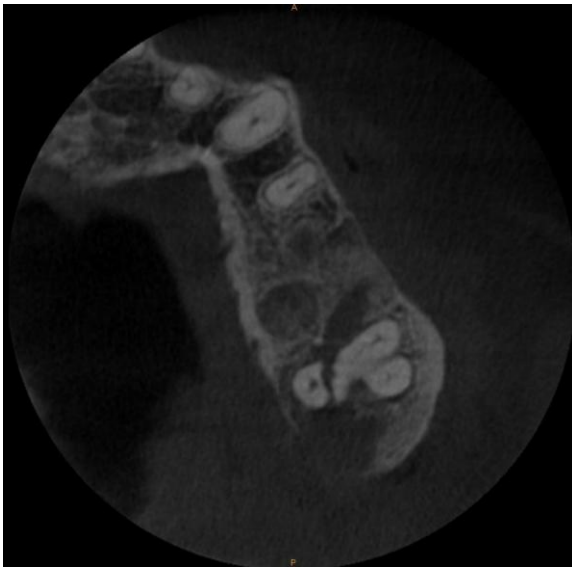
Figure 2

A small-field Cone Beam Computed Tomography (CBCT) scan was prescribed to evaluate site #14 prior to implant placement and to evaluate tooth #15. The CBCT scan was taken with the Carestream 9300 with a 5x5cm field of view at 90  $\mu$ m. The CBCT clearly diagnosed a palatal root fracture on tooth #15 from the cross sectional and axial scan views (see Figures 2 and 3). The extraction was performed.

This is a case which clearly demonstrates the value of 3D CBCT imaging in dentistry. A fracture which was not clearly seen on a traditional 2D radiograph and was not clinically evident was confirmed with amazing clarity using small field CBCT. Such an issue could have severely compromised the patient's initially proposed course of treatment.

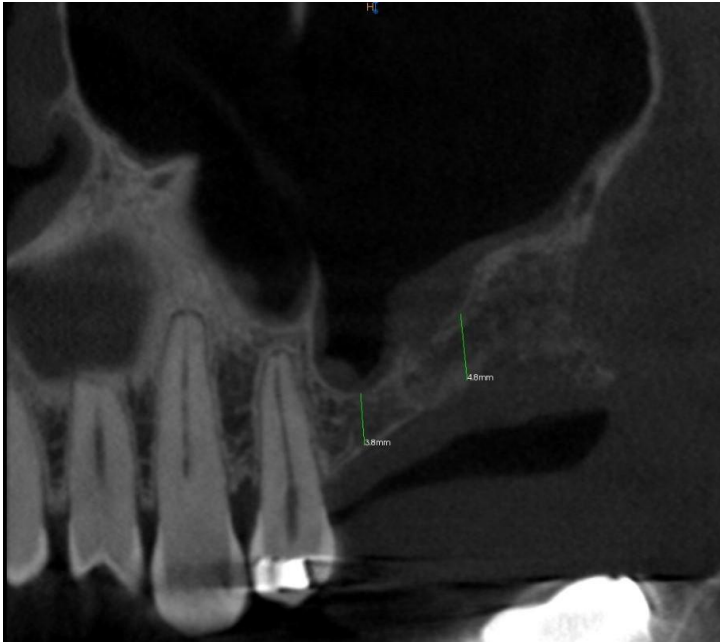
Figure 4

A post-extraction small field CBCT was acquired to evaluate the edentulous site for evaluation sinus health and for bone height prior to sinus lift and simultaneous implant placement (see figure 4). Measurements from the crest of the alveolar ridge to the floor of the sinus were taken at the sites of the first and second molars and were found to be 3.8mm of bone height and 4.8mm of bone height, respectively.

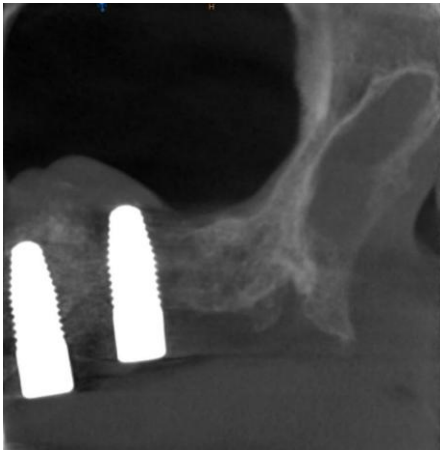
Figure 5

A sinus lift procedure was performed, and two implant fixtures were placed. A follow-up CBCT volume was taken one month later to check for overall healing, graft containment and sinus health (see figures 5 and 6). This scan demonstrated normal healing from all perspectives.
