CS 8100 3D and CS Solutions

CBCT and CAD/CAM Allow for One-Day Restoration of Tooth #9

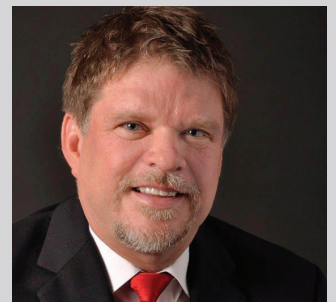
Robert Pauley, Jr., DMD
