## CS 9300 System

# CBCT Scan Reveals Previous Unsuccessful Bone Graft

Craig Misch, D.D.S., M.D.S., P.A.

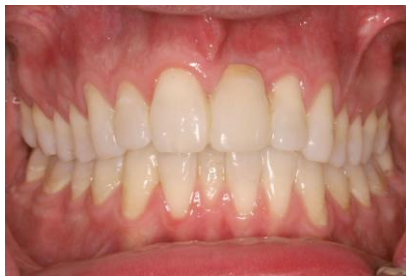
Fig. 1

A healthy male patient presented at my office seeking an implant to replace the maxillary left central incisor (# 9). His general dentist had extracted the tooth and performed a socket bone graft and the patient felt more comfortable having a specialist place the implant. The patient was eager to begin treatment and was confident he had enough bone. Indeed, the initial clinical exam also gave me the impression of plenty of bone (Fig. 1).

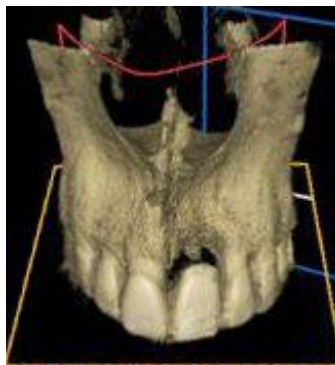
Fig. 3

Although it initially appeared that there was adequate ridge width, a computed tomography (CT) image (Fig. 2) revealed that the ridge was deficient; it was resorbed and too palatal. A cone beam computed tomography (CBCT) image captured with the CS 9300 confirmed that the previous socket bone graft was unsuccessful, leading to vertical and horizontal bone deficiency (Fig. 3).

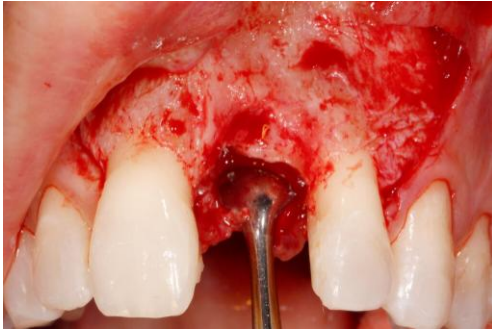
Fig. 4

The defect was exposed (Fig. 4) and the site grafted with autograft harvested from the site with an AMC bur (Fig. 5). The area was then augmented with BioOss (Fig. 6) and the site was covered with Ossix Plus collagen membrane (Fig. 7). A post-op cone beam CT scan was taken to confirm the success of the graft (Fig. 8). The graft healed very well and the patient was pleased with the results. So pleased, in fact, that he posted a rave review on the practice Facebook page.
