## CS 3500 Intraoral Scanner

# Digital Impression Combination Case

Daniel C. Delrose, DDS

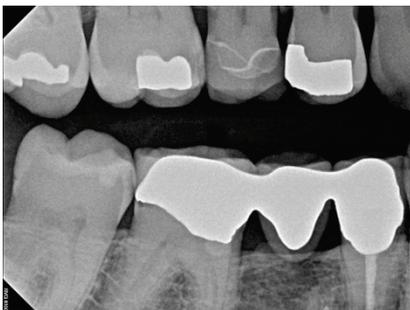
Fig 1

Tooth #4 had recurrent decay, and a CS Solutions Vita Mark II crown was done at her next appointment (*Fig1*). Feeling confident again in modern dentistry and the technology of the CS Solutions, she scheduled an appointment for an implant in the area of #29.

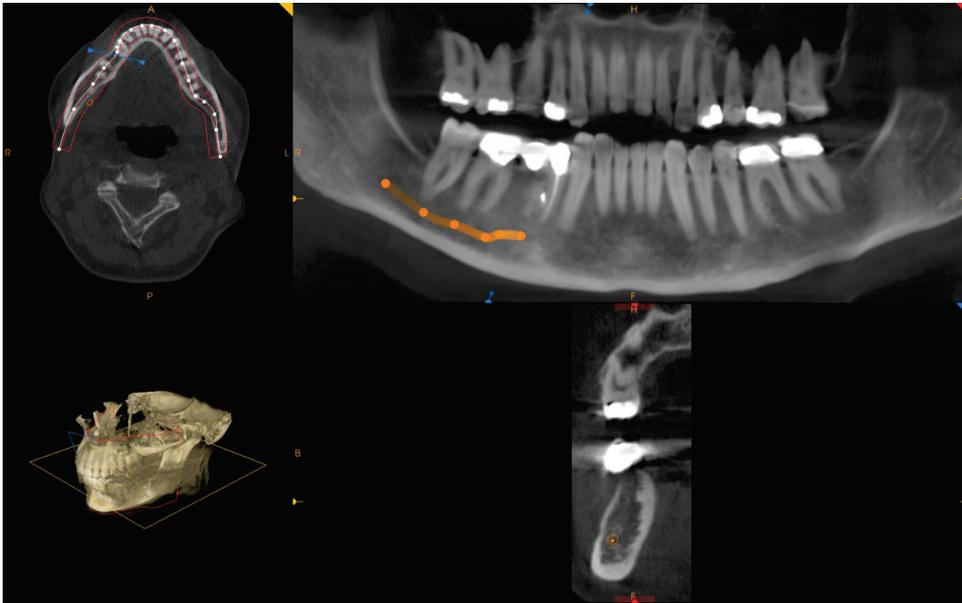
Fig 2

Utilizing the CS 9300 and Digital Imaging Software, an implant was planned for the area of #29 (Figs 2 and 3).

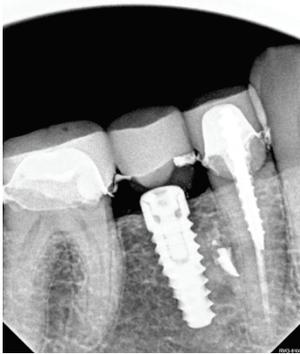
Fig 4

The fixed porcelain fused to metal partial denture was removed, a post was placed in tooth #28, and a buildup was performed on the mesial buccal of #30. A BioHorizons 3.8mm tapered internal implant was placed as planned using the CS 9300. Next, a temporary fixed bridge was placed, and the patient was asked to return in ten weeks for a final impression (Fig 4).

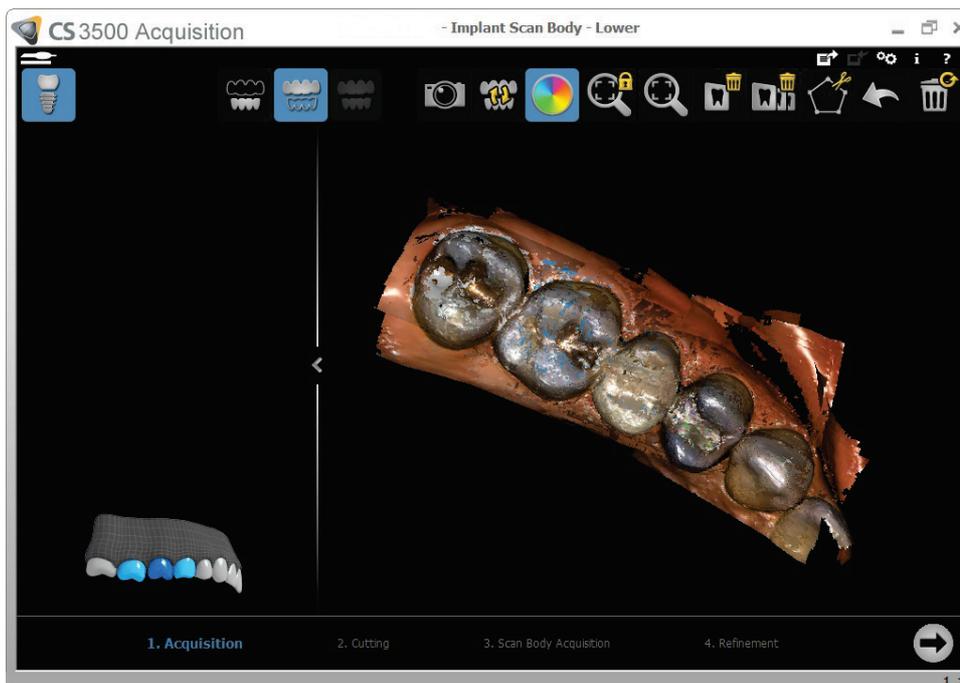
Fig 5

An opposing impression was taken by the dental assistant (*Fig 5*), and the temporary was removed. Using light infiltration in the area of the implant, the implant was uncovered and a healing abutment was placed. Retraction was facilitated with the diode laser and the preparations were scanned (*Fig 6*). The best aspect is taking the bite—three more pictures, and you see exactly how the models will be mounted virtually (*Fig 7*).

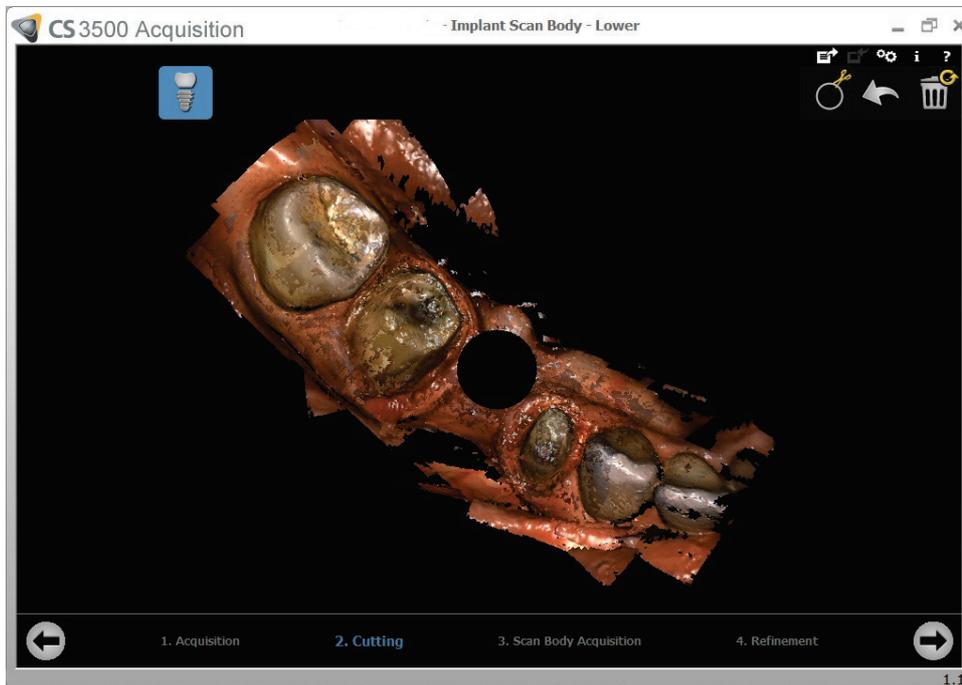
Fig 8

The healing abutment was removed and the scan abutment placed. The easy “cut tool” was used to erase the healing abutment, so all that needed to be scanned was the scan abutment. The workflow was directed by the CS 3500 and its acquisition software (Fig 8). Next, the scan abutment was imaged and the software did the rest (Fig 9).

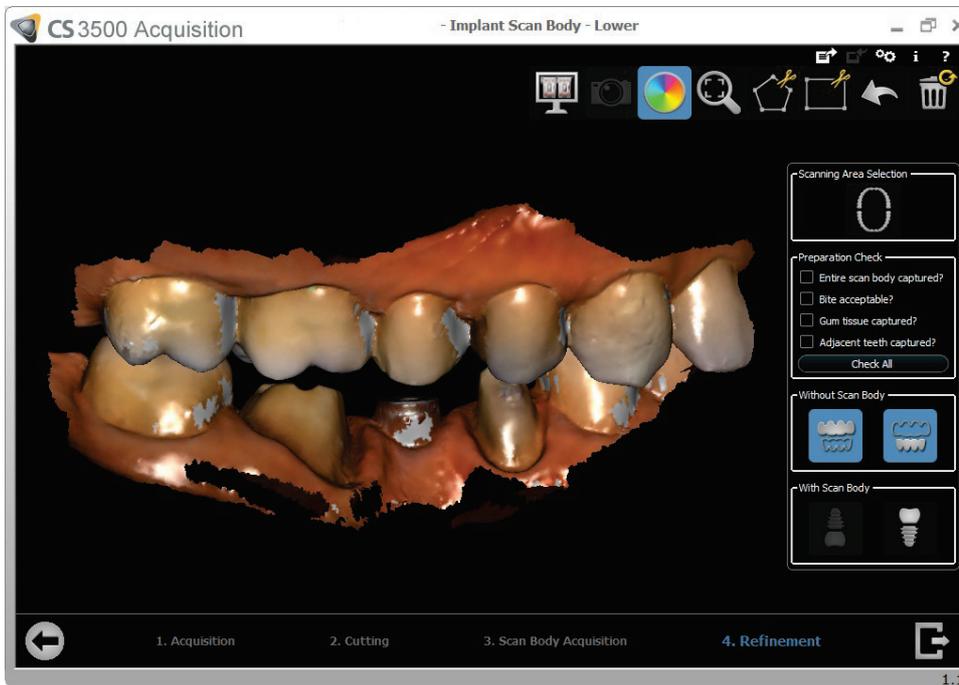
Fig 10

The healing abutment was initially placed to show the lab the gingival contours wanted for clinical parameters of the custom abutment. The software was then used to refine the digital impression and show the model (Fig 10 and 11). The refined model was saved as a STL file that could be electrically sent via a HIPPA-compliant portal, which is also part of the CS 3500.

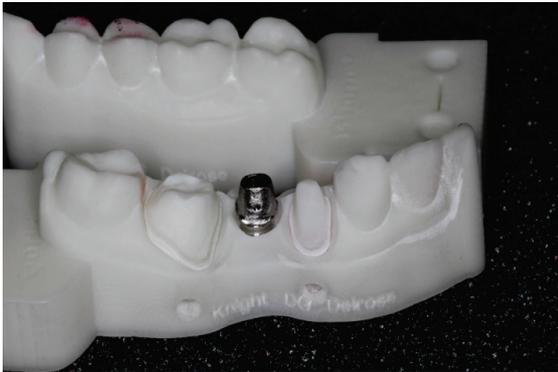
Fig 12

In less than two weeks, the dental laboratory returned printed models with the custom abutment and three full-coverage crowns (Figs 12 and 13). The abutment and restorations were dry fitted, the custom abutment was torqued to 35Nm and all the restorations were delivered (Figs 14-16).
